TECHNICAL REPORT HL-83-21

NAWILIWILI BREAKWATER STABILITY STUDY NAWILIWILI HARBOR, KAUAI, HAWAII

Hydraulic Model Investigation

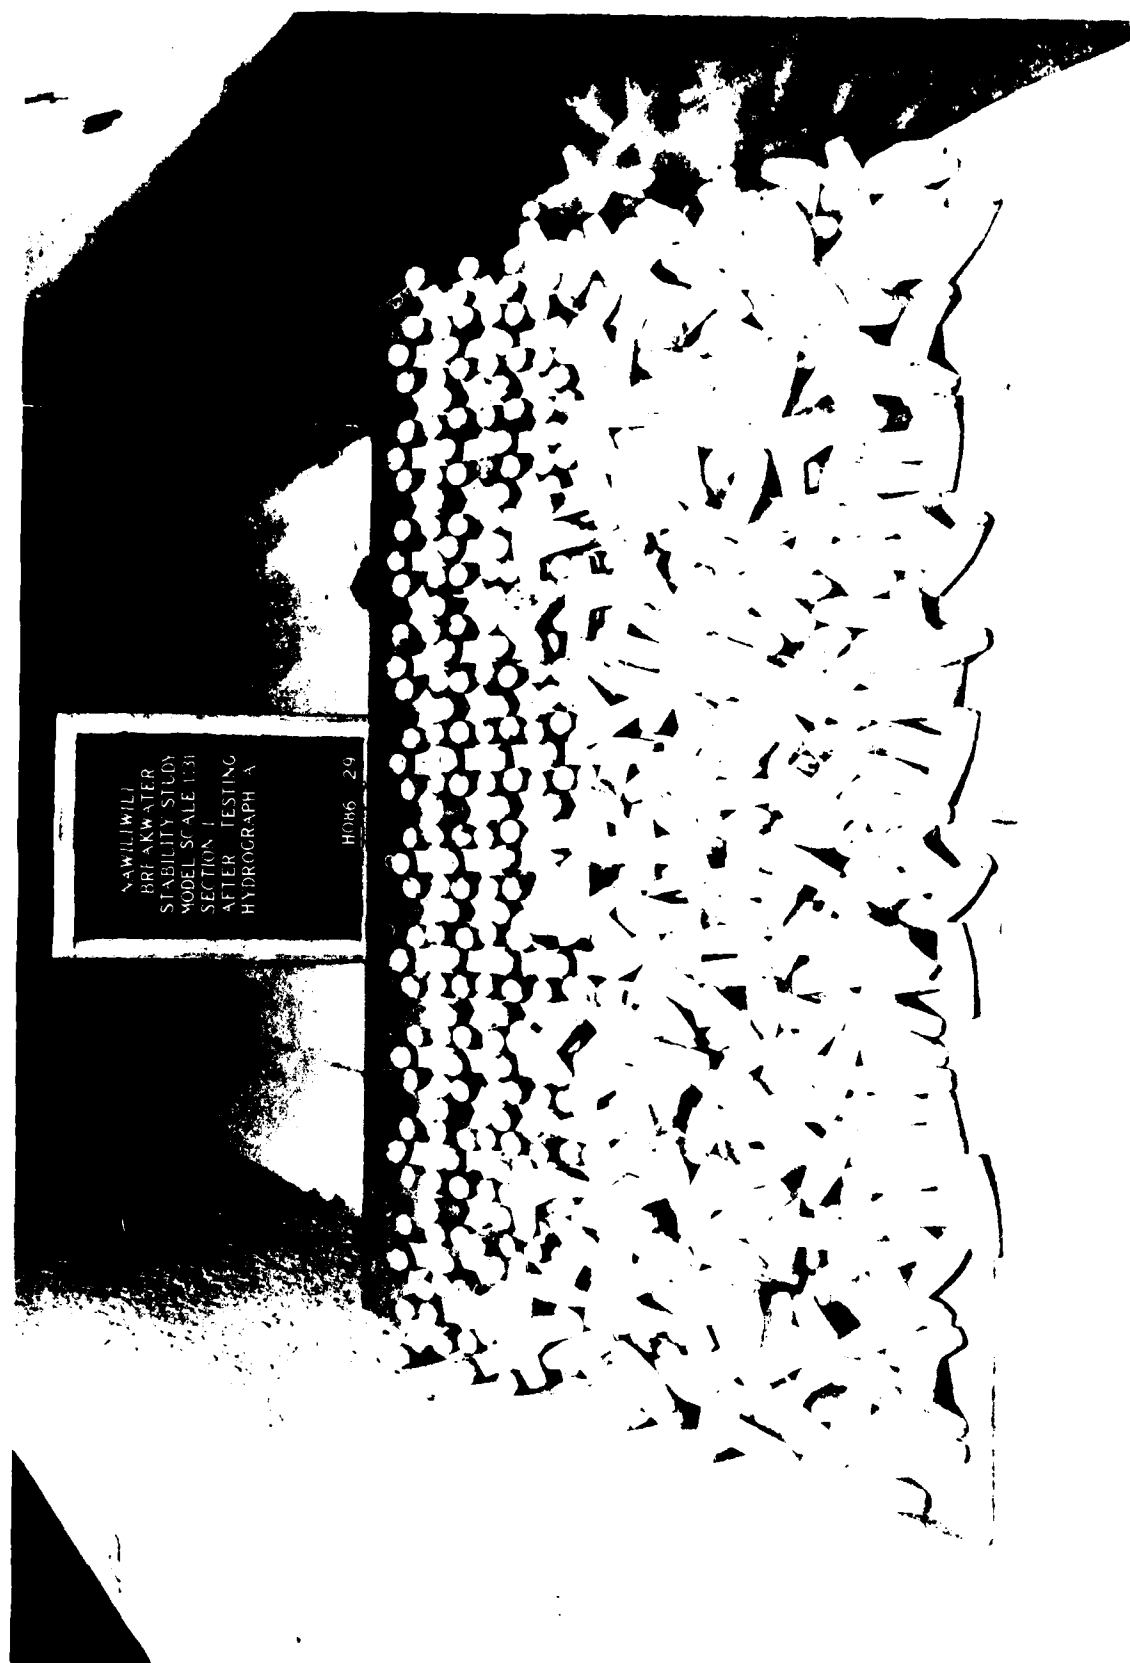
17. Section 1, Plate 4 and Photos 2-4, was constructed in the test flume at a scale of 1:31 and reproduced, as closely as possible, the existing conditions at sta 19+50 as described in the preceding paragraph. Due to the mixing of various types of prototype concrete armor units and limited range of available model armor unit weights, it was necessary to represent the existing 22,000-lb dolosse and 35,600-lb tribars as having prototype weights of 23,318 lb and 32,995 lb, respectively. The 16,000- to 20,000-lb keyed and fitted stone was represented by average individual stone weights of 18,000 lb with a linear gradation of ± 15 percent by weight. Section 1 was exposed to the wave and swl conditions of Hydrograph I and by the end of the test, the dolosse had sustained moderate to significant damage, 11 to 15 dolosse displaced upslope and 14 to 20 displaced downslope and were retained just off the dolos toe area (Photos 5-7). The dolos armor showed moderate to significant rocking in place and reorientation throughout the test. At different points during the test, it was estimated that as many as 50 dolosse showed

some type of in-place movement. Significant wave overtopping was noted throughout the hydrograph steps, but the majority of the overtopping wave energy was deflected into the harbor-side swl by the concrete cap; therefore the harbor-side armor stone was only exposed to minor amounts of overtopping wave energy. Only one armor stone was displaced off the harbor-side slope and no other movement or damage was observed. Although in-place dolos movement was noted throughout the test, no additional damage or displacement occurred during the last 45 min of Hydrograph I.

Photo 6. Sea-side view of Section 1 after testing

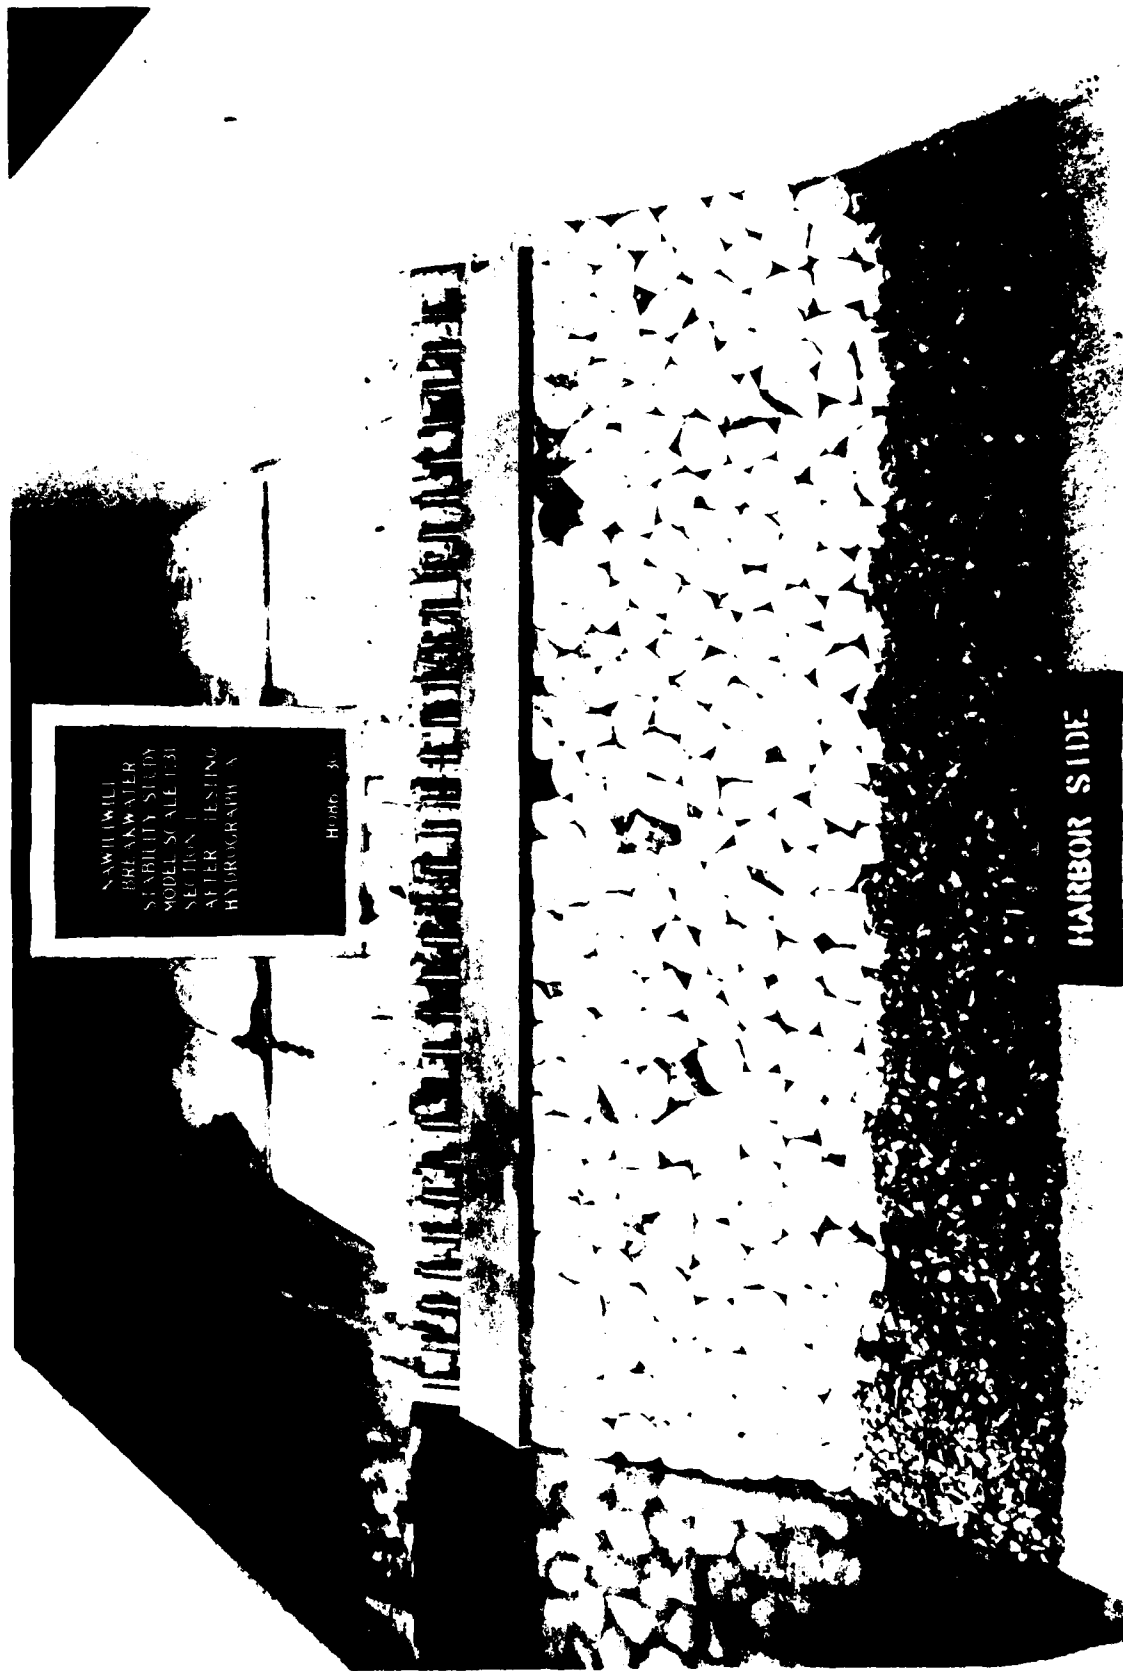
Photo 7. Harbor-side view of Section 1 after testing

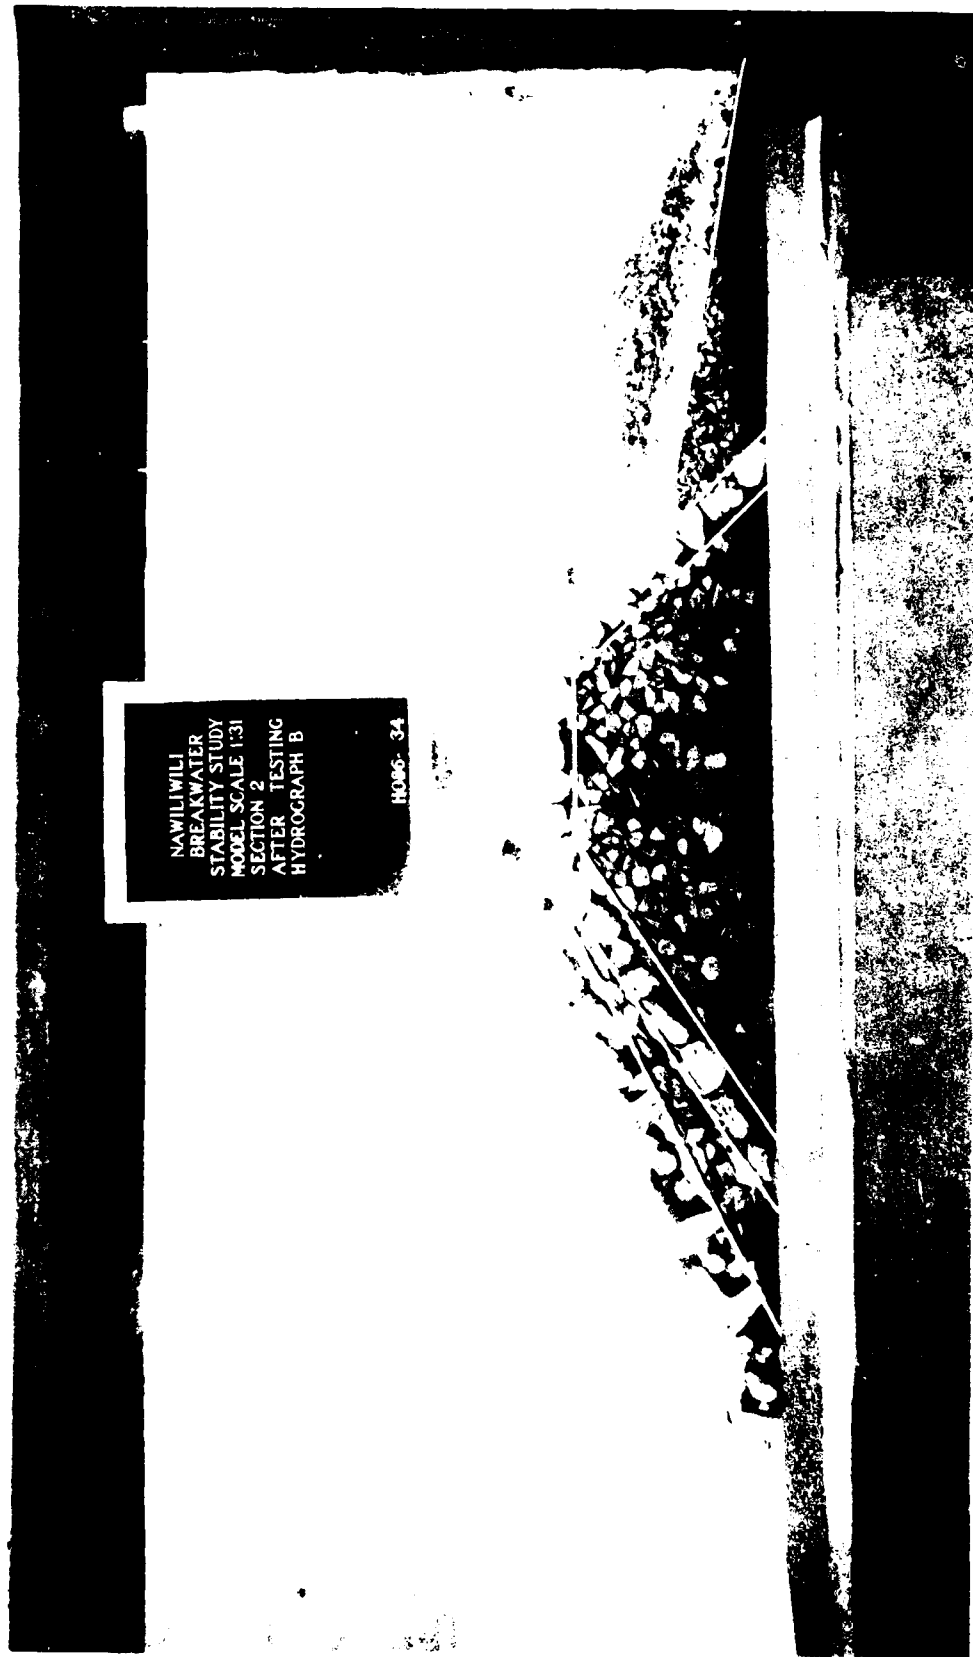
remainder of the test. The overall condition of the breakwater appeared good at the end of the test (Photos 11-13).

Photo 11. Side view of Section 2 after testing, first test section

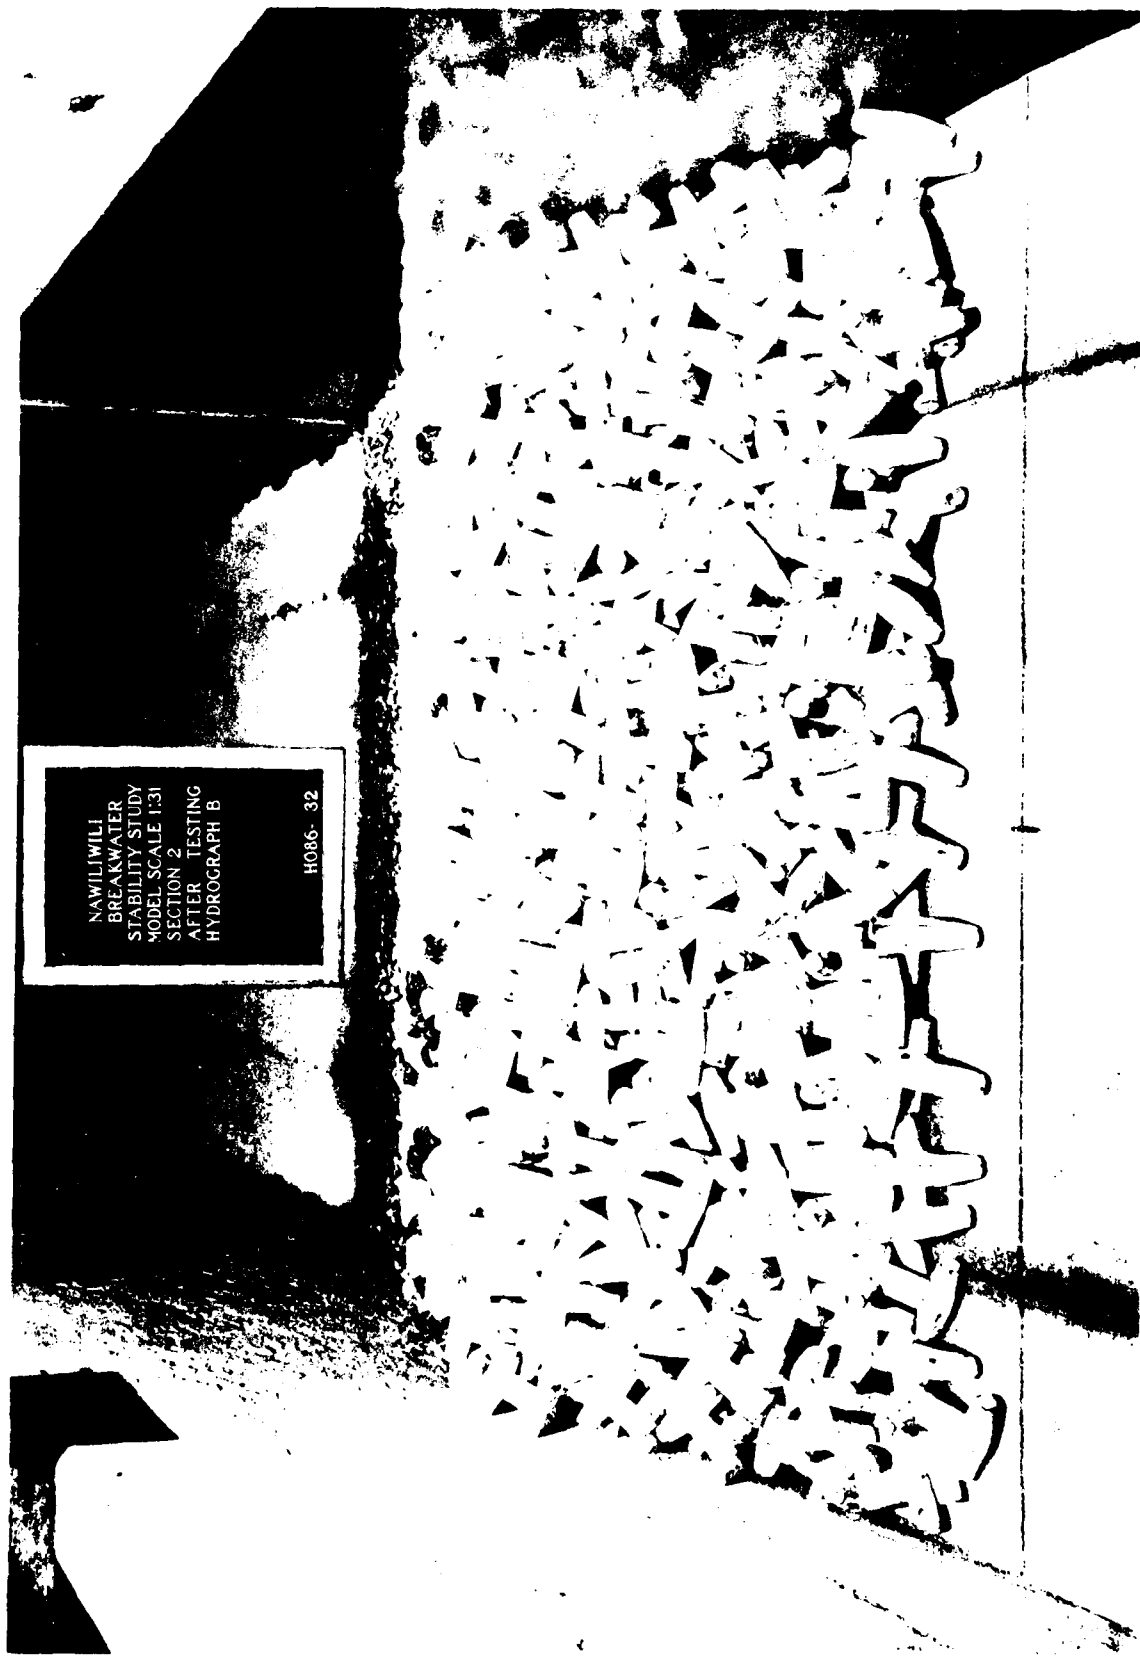
Photo 12. Sea-side view of Section 2 after testing, first test section

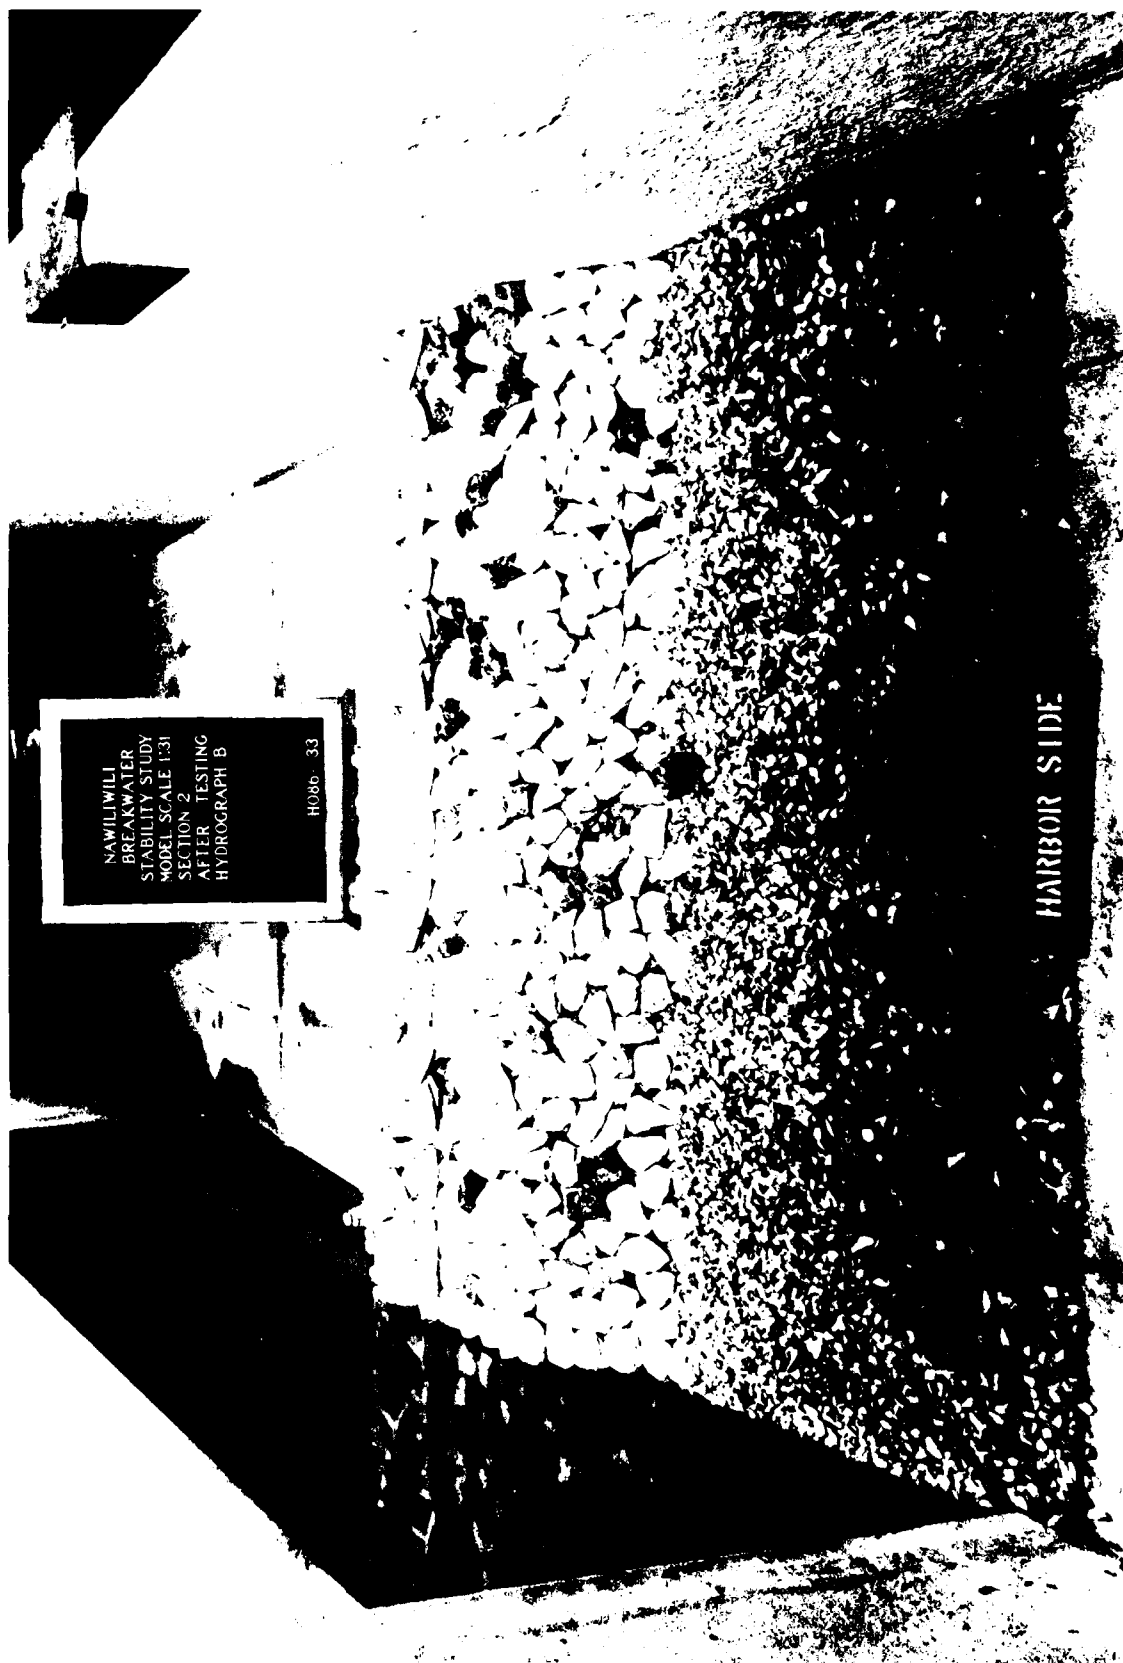
Photo 13. Harbor-side view of Section 2 after testing, first test section

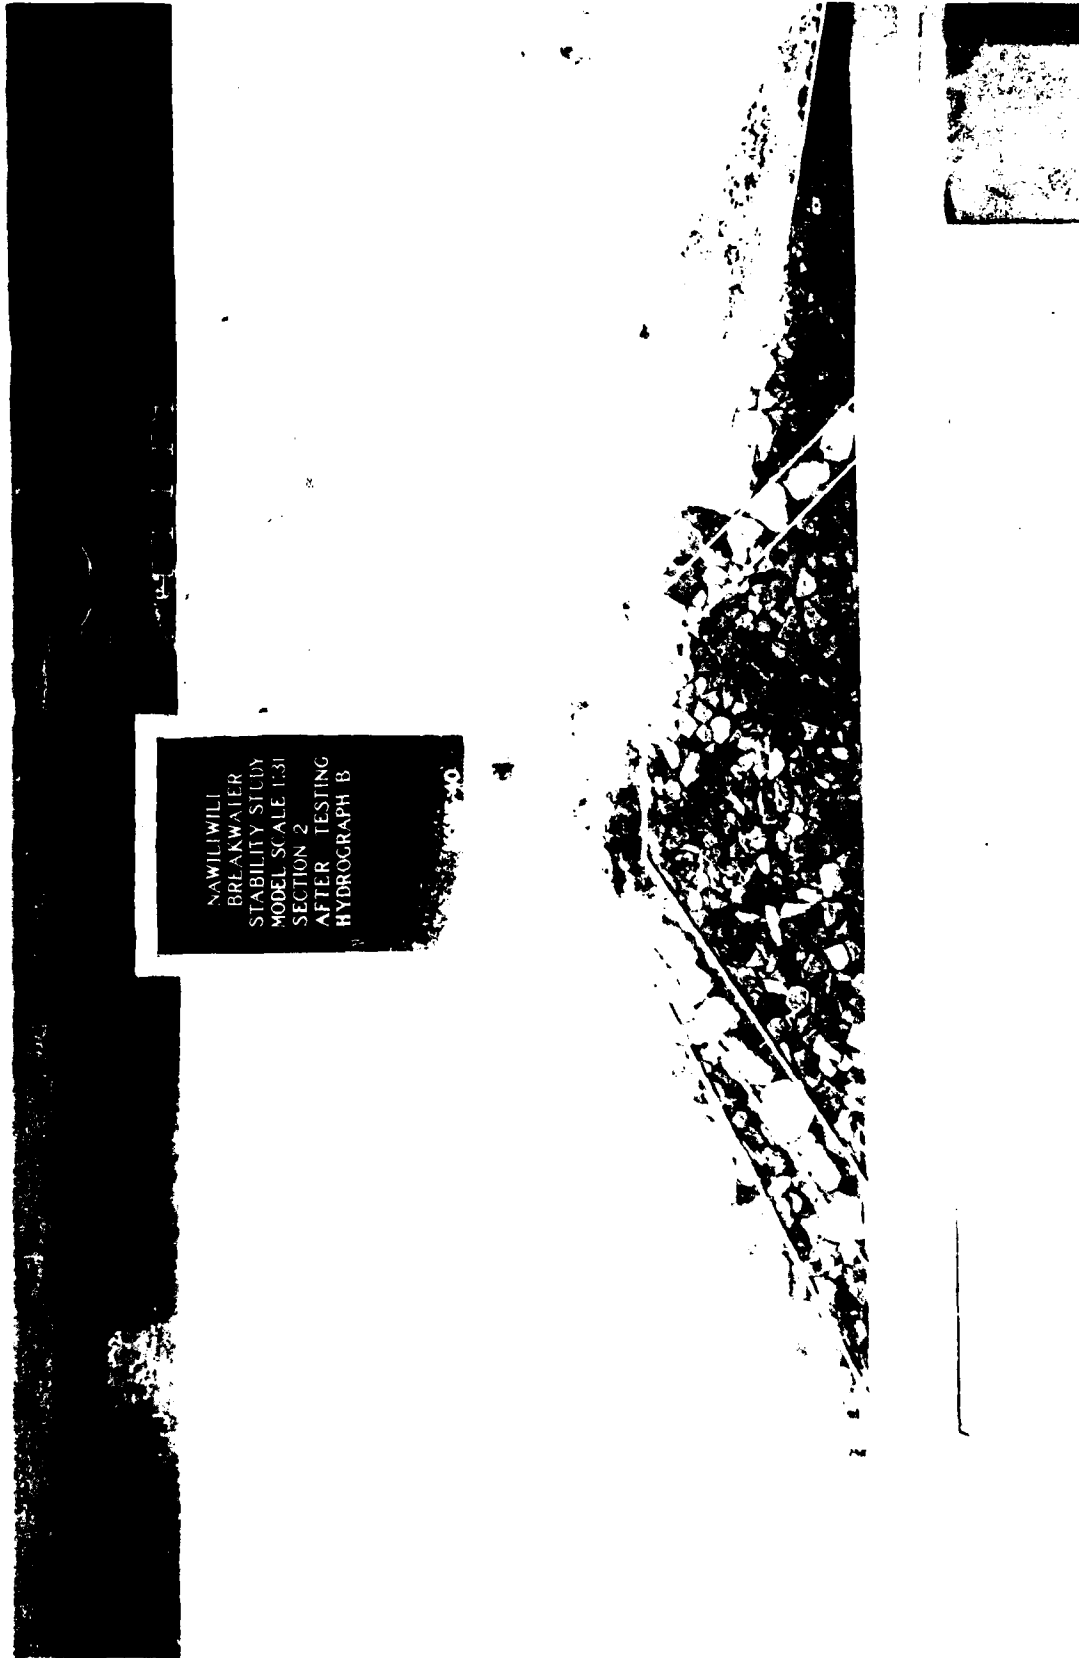
21. The test section was rebuilt and once again exposed to the test conditions of Hydrograph II. For this test, the hydrograph steps were reversed to see what effect, if any, this would have on the test results. (This hydrograph step reversal had been done during testing of Section 1 and no effects were noted on the overall test results.) Step 3 produced extensive damage on the crown and harbor-side slope. Early in Step 3, two of the keyed and fitted armor stone were displaced (one from the crown and one from just below the swl). Following this displacement, the crown and harbor-side slope began to unravel with each successive wave. One dolos was displaced from the crown onto the harbor-side rubble stone. By the end of Step 3, damage to the crown and harbor-side slope had slowed down, but the majority of the crown stone had been displaced and the overtopping waves had displaced a significant amount of core material. The armor-stone crown had failed, but this did not result in any undermining or displacement of dolosse along the sea side of the crown. Although the crown and harbor-side slope were considered failed, the structure was exposed to Steps 2 and 1 to see if these conditions would displace any of the crown dolosse or cause any other additional damage. These conditions caused no additional damage, but some moderate in-place rocking of dolosse on the lower sea-side slope and a slight shift toward the harbor-side were noted on a few of the crown dolosse. By the end of the test, all damage had stopped. The sea-side dolosse were in good condition and the armor-stone crown and harbor-side slope were in need of total rehabilitation (Photos 14-16).

Photo 14. Side view of Section 2 after testing, second test section

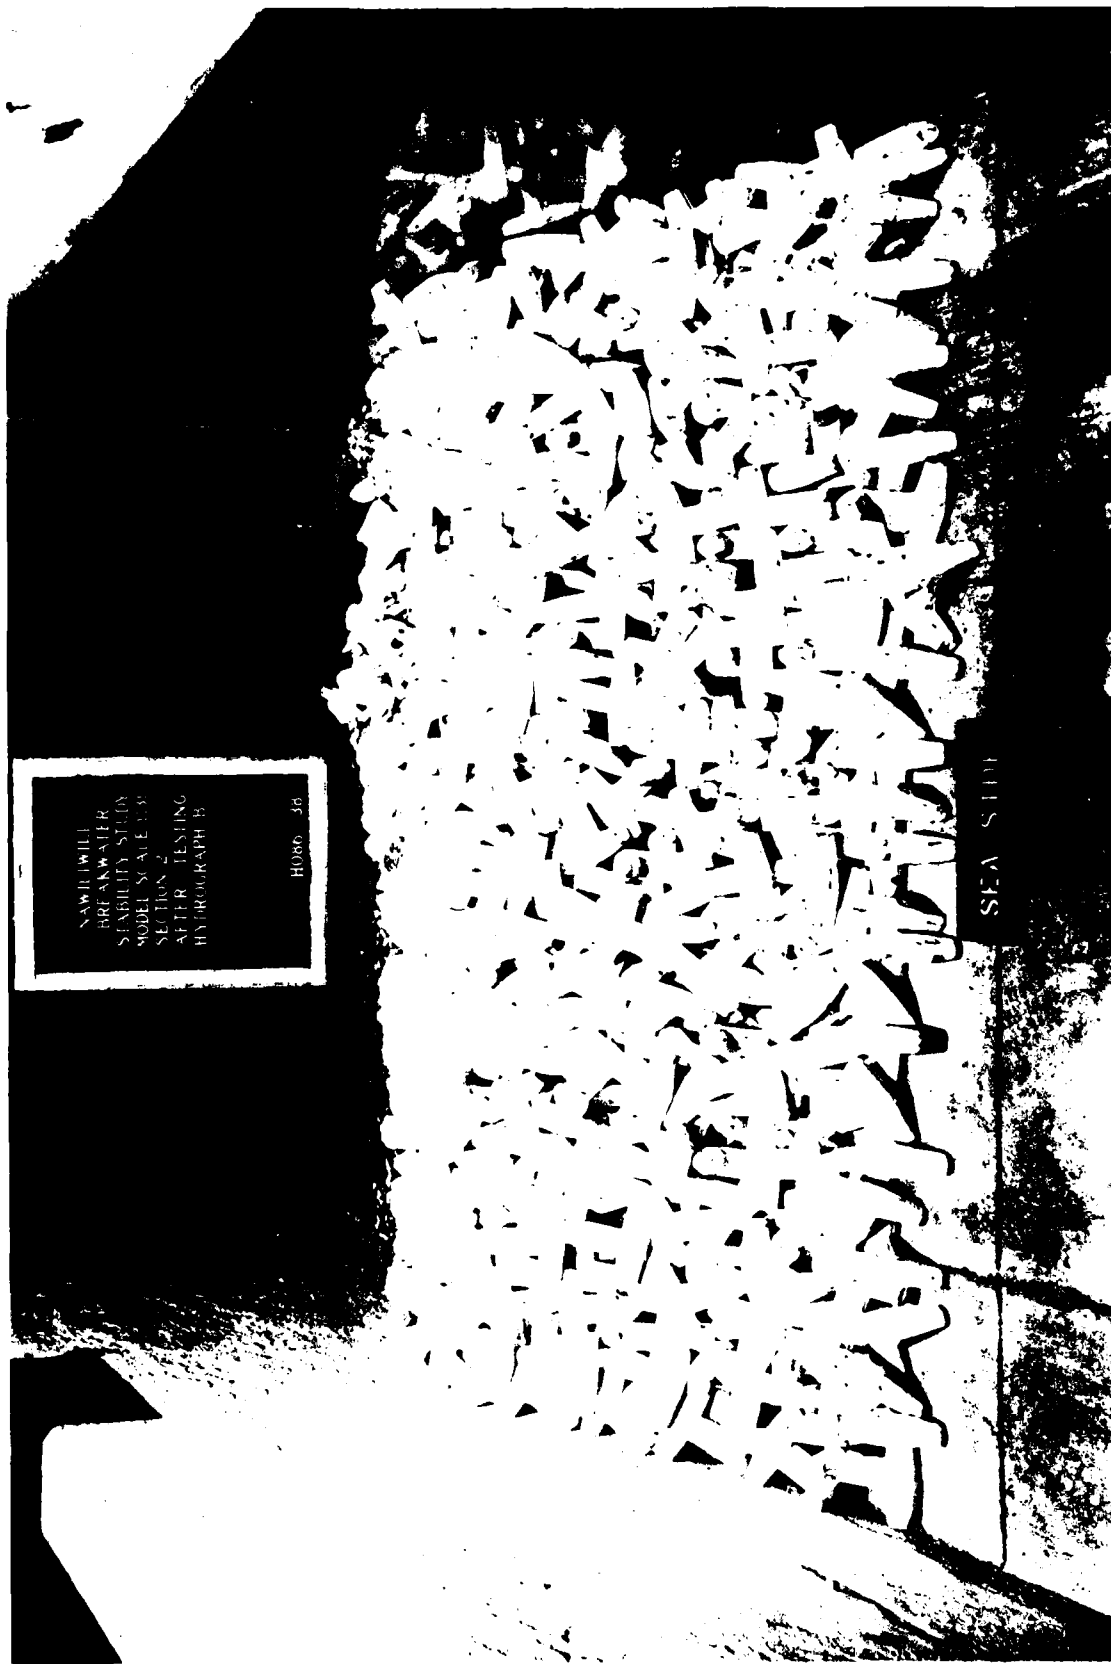
Photo 15. Sea-side view of Section 2 after testing, second test section

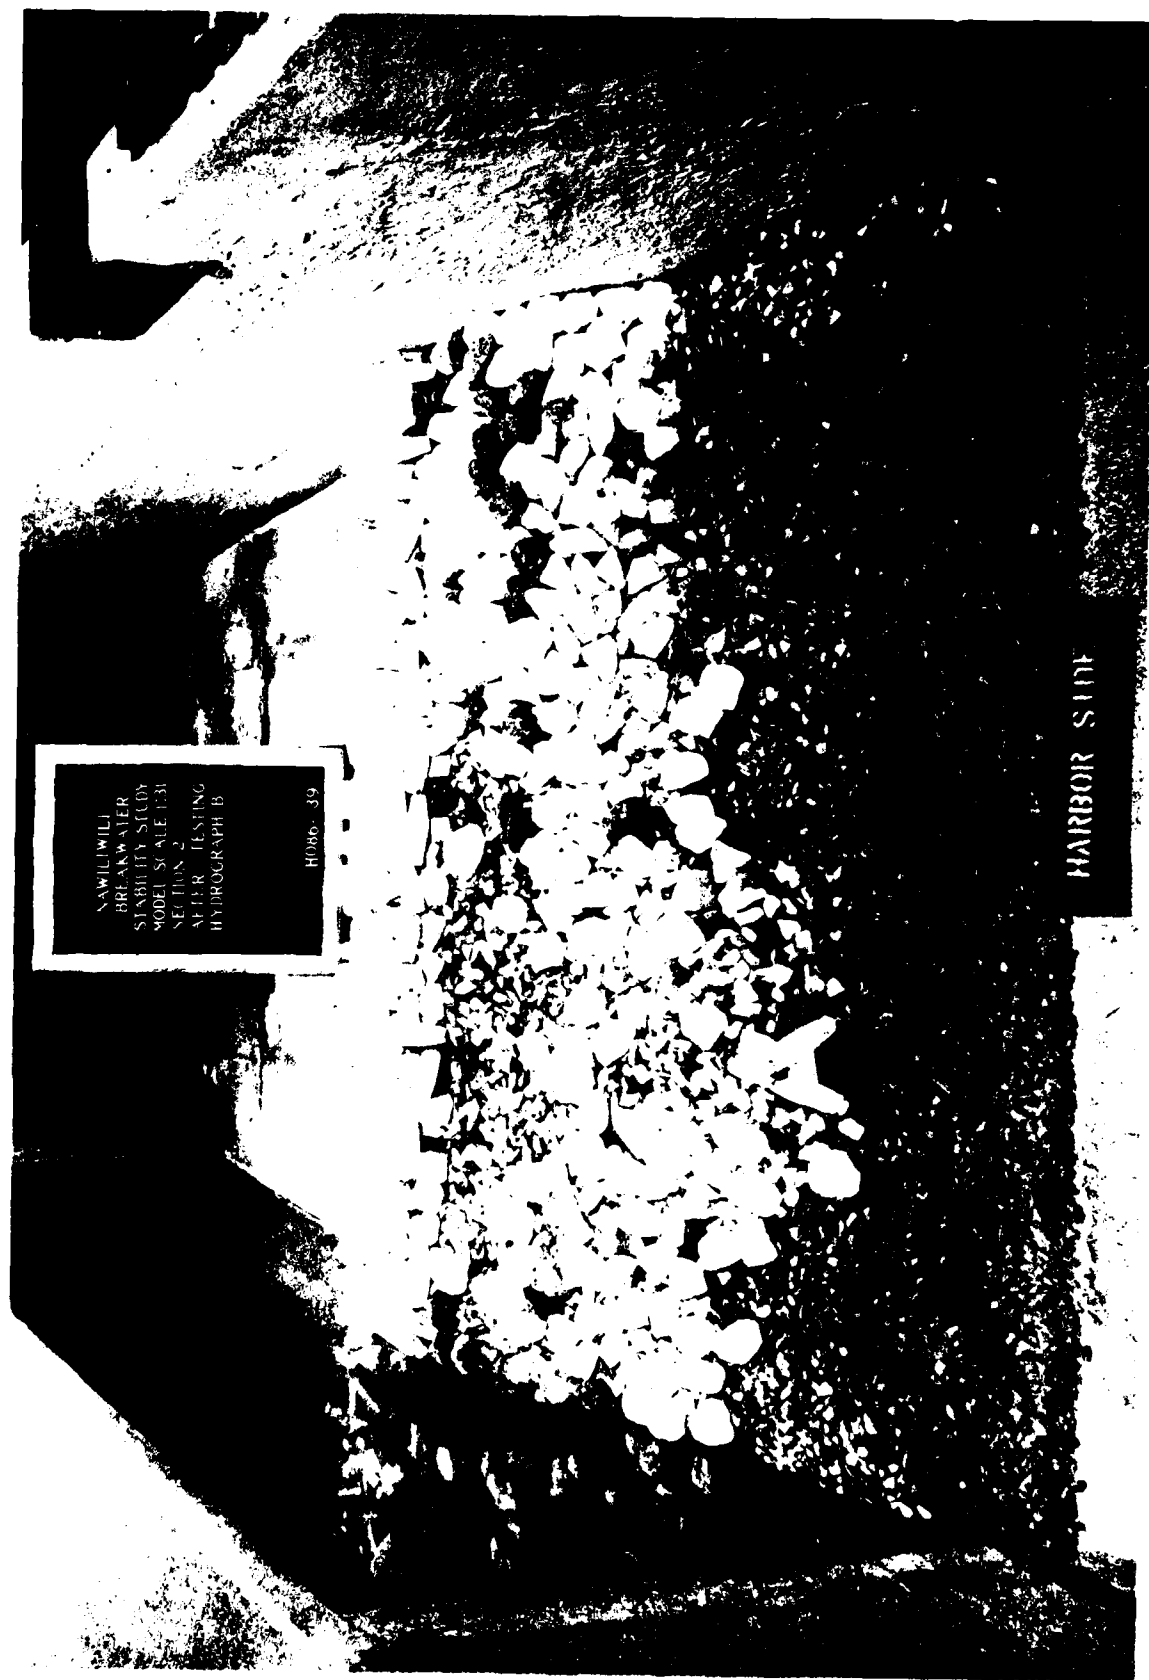
Photo 16. Harbor-side view of Section 2 after testing, second test section

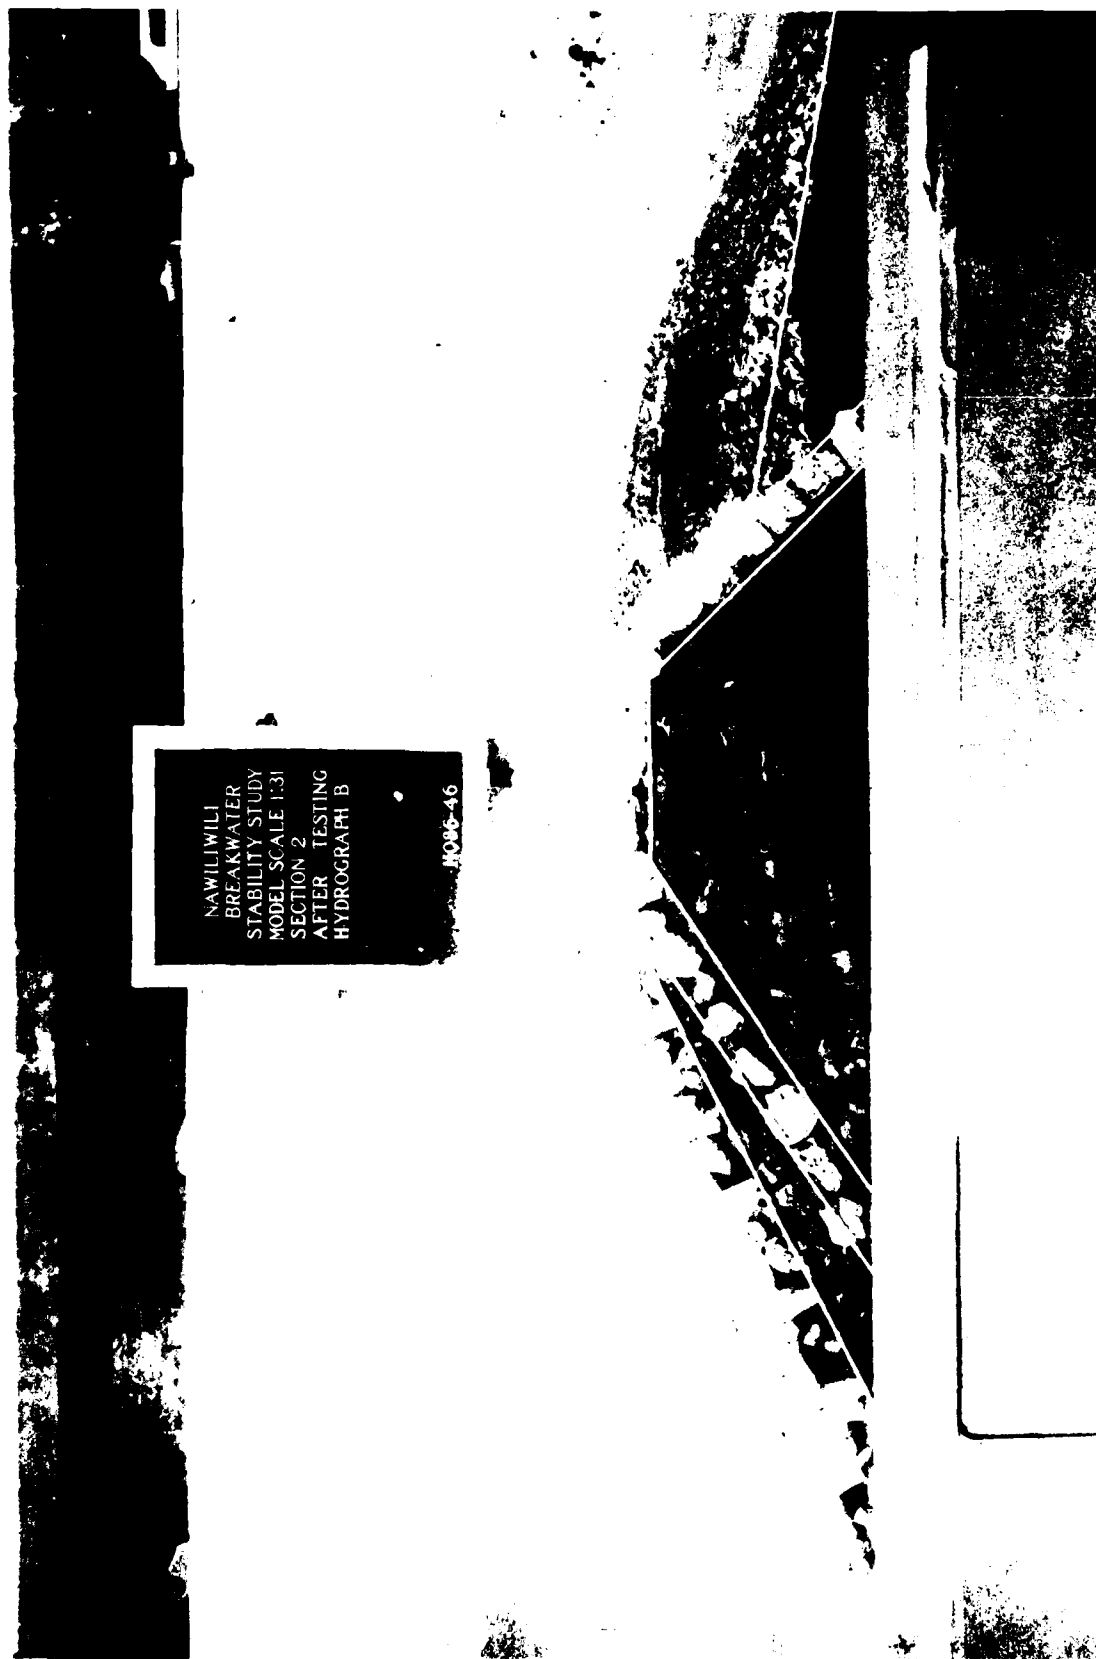
22. It was noted during the construction of the second test section that the keyed and fitted construction achieved was not as tight as had been reproduced on the first test section. This may very well have been the reason for the failure of the second test section. Not knowing exactly how tight the existing prototype keyed and fitted armor stone actually are, it was decided to rebuild the test section. During this building, an effort was made to achieve the same tightness of construction as had been accomplished on the first test section. The test section was once again exposed to Hydrograph II. The hydrograph steps were run in reverse to see if the tighter crown and harbor-side slope construction would prove stable for the selected test conditions. One armor stone was displaced from the upper harbor-side slope

during Step 3 and minor to moderate in-place rocking of 10 to 12 dolosse was noted throughout the hydrograph. No other movement or damage occurred and the structure was in good condition at the end of the test (Photos 17-19).

Photo 17. Side view of Section 2 after testing, third test section

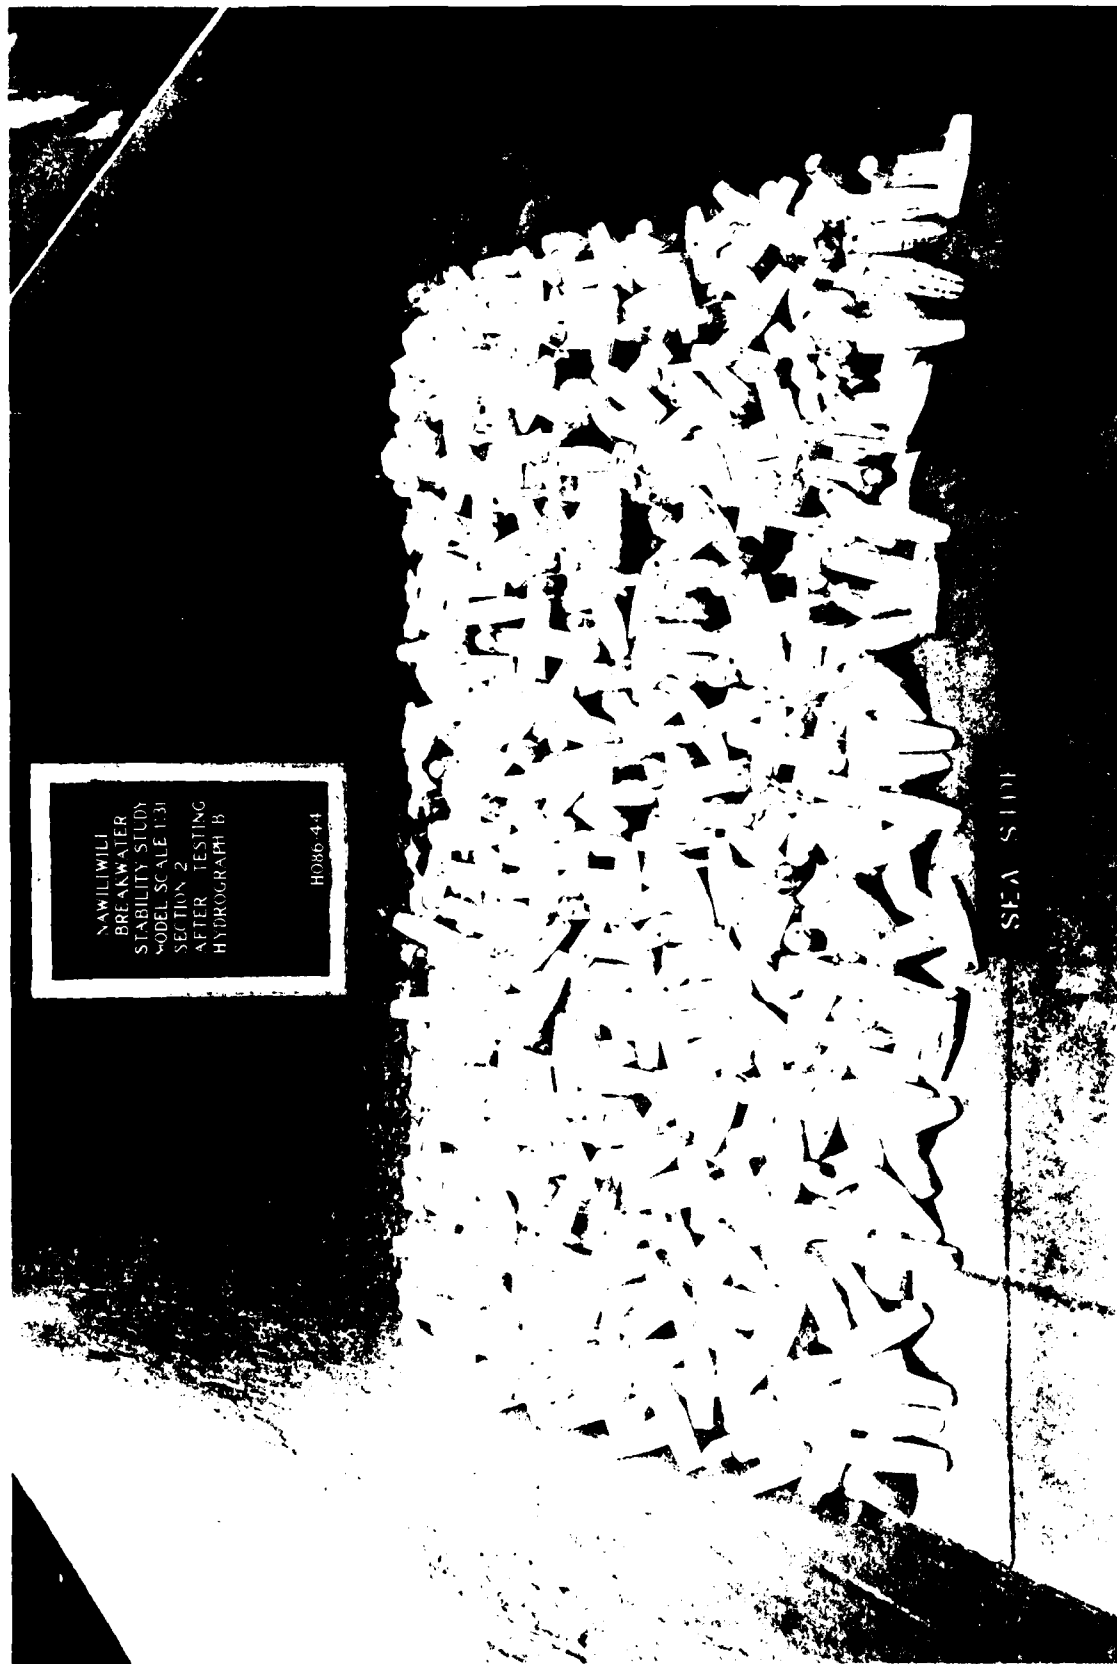
Photo 18. Inboard view of Section 2 after testing, third test section

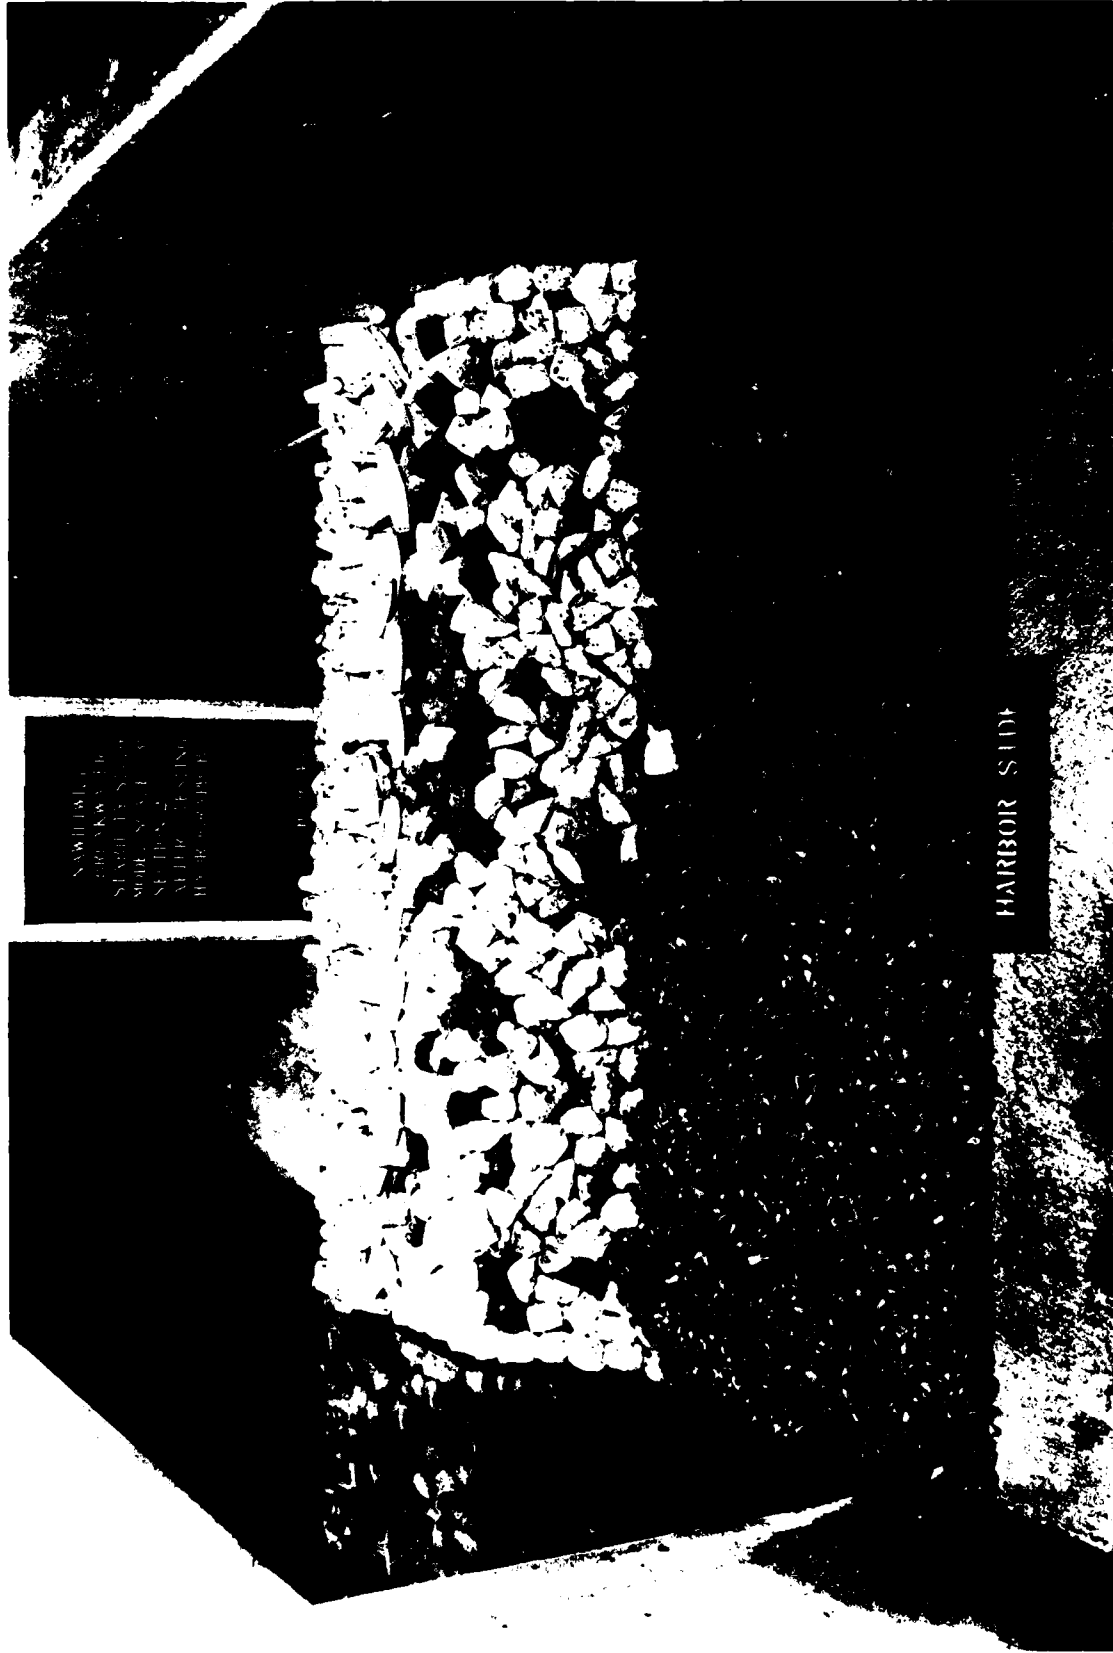
Photo 19. Harbor-side view of Section 2 after testing, third test section
